METALS HANDBOOK

VOL. 9
FRACTOGRAPHY AND ATLAS OF FRACTOGRAPHY

8th EDITION

Fractography and Atlas of Fractographs

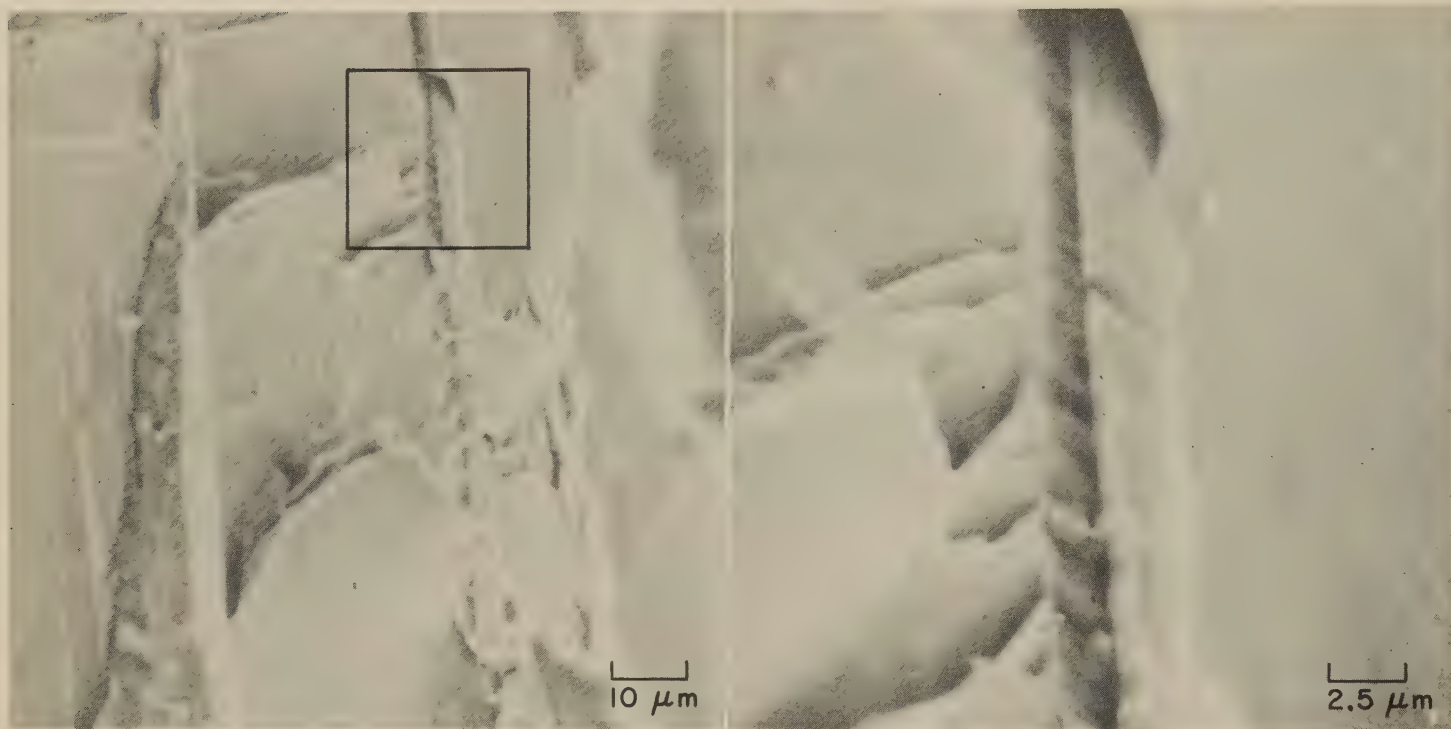
3561 Surface of a fracture that was obtained by bending a notched specimen of high-purity iron (containing less than 1 ppm of carbon) at -196°C (-321°F). The root of the notch was oriented parallel to the $\langle 110 \rangle$ crystal direction. Cleavage on several parallel planes is evident. Area in rectangle is shown in 3562.

3562 Higher-magnification view of the area within the rectangle in fractograph 3561 (at left). The vertical mark is a twin from which numerous cracks have nucleated. A straight groove at the center of the twin shows evidence of a shear-type fracture. Note the parallel cleavage steps within the twin.

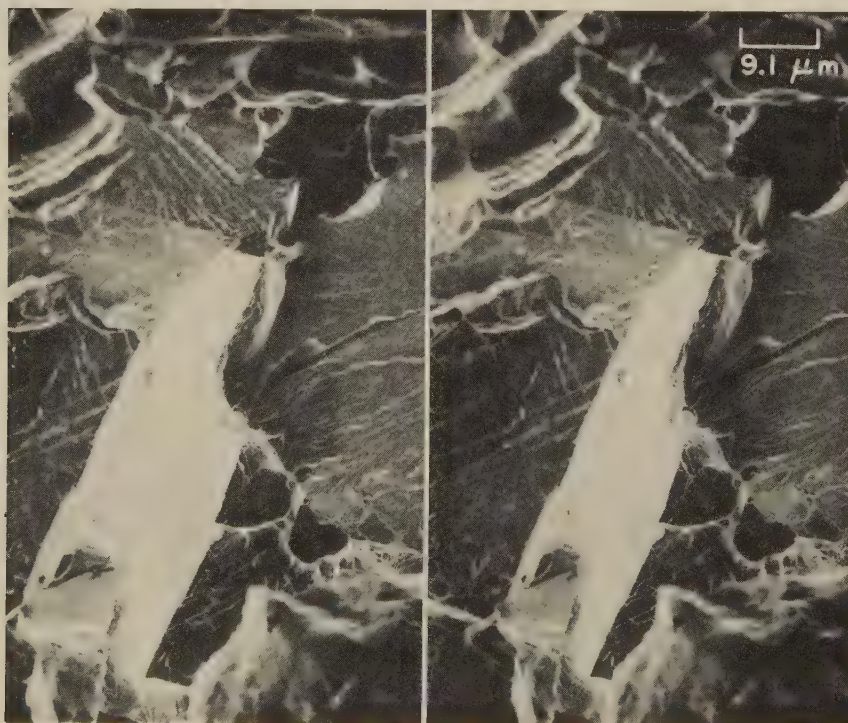
3563 Stereo pair of scanning electron microscope views of the fracture surface of a Charpy impact test bar of high-purity iron. The specimen was broken after being cooled to equilibrium in liquid nitrogen (-196°C ; -321°F). The use of a

stereo viewer (or of any of the other stereographic techniques described on pages 281 and 282) is highly recommended, because it is only by these methods of appraisal that the angular relationships of the fracture facets can be appreciated.

With 3-D viewing, it will be observed that surprisingly flat cleavage has taken place on a variety of sharply divergent crystal planes. There are fine river patterns evident on nearly all of the facets. The cleavage steps that delineate the "river" systems are, however, very minute in height, providing only very small departures from a single crystallographic plane of crack growth. Characteristic of iron when fractured at low temperature is the formation of "tongues", one of which is located at the lower end of the very bright facet. Note that there even appears to be a river pattern on the left-hand portion of the "tongue". A second, smaller tongue projects from the facet shown obliquely at top left. The edges of some of the facets are exceedingly sharp. One example is the lower right-hand edge of the bright facet. Another that appears to be razor sharp is to the left of and just above the same very bright facet.

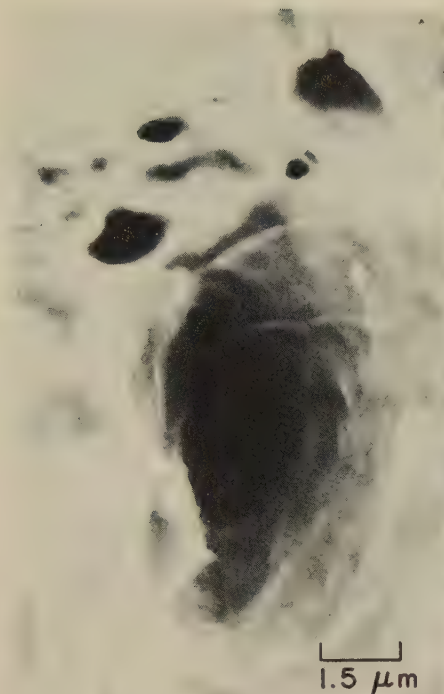
SEM fractograph 6500×
3564 Surface of a tensile-test fracture in a specimen of pure iron that was broken at room temperature. The reduction in area was nearly 100%, which produced a very limited fracture surface. Present are the dimples characteristic of tension overload, but no nonmetallic inclusions were found throughout the fracture.

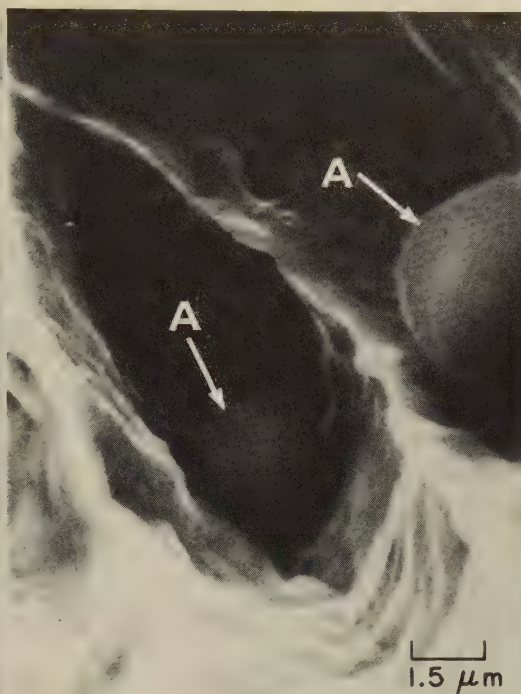
SEM fractograph 6500×
3565 Room-temperature tensile-test fracture in a specimen taken from an ingot prepared by adding 0.05% pure silicon to pure iron in a vacuum melt equilibrated at 1550 C (2822 F) in a silica crucible. Fracture surface shows dimples that contain spherical SiO_2 inclusions averaging 3.4 μm in diameter. Separation of inclusions from the matrix was indicated (arrows A). See 3567 and 3568.

SEM fractograph 2400×
3567 View of the shear-lip region of the fracture surface shown in fractograph 3565. The surface here is greatly distorted, similar to the interior of the dimples visible in 3565. The globular inclusion is SiO_2 .

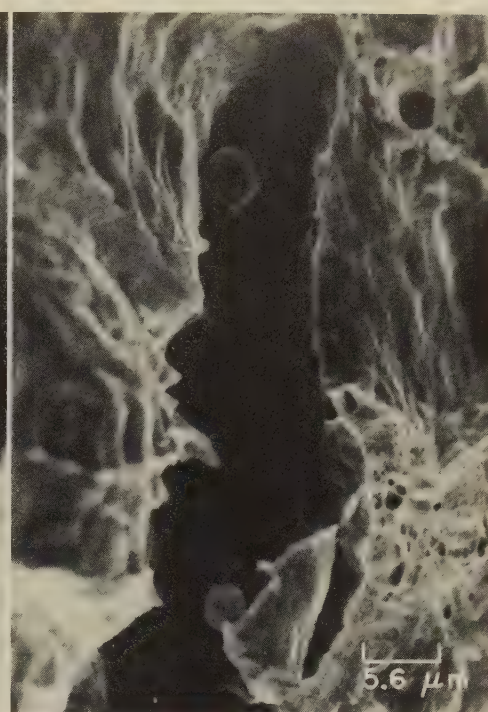
SEM fractograph 1800×
3566 Surface of a room-temperature tensile-test fracture in a specimen taken from an ingot prepared by adding Fe_2O_3 to pure iron in a vacuum melt equilibrated at 1550 C (2822 F) in a silica crucible. The ingot contained 0.07% oxygen in the form of FeO. The fracture surface contains dimples that initiated at globular FeO inclusions averaging 5.2 μm in diameter.

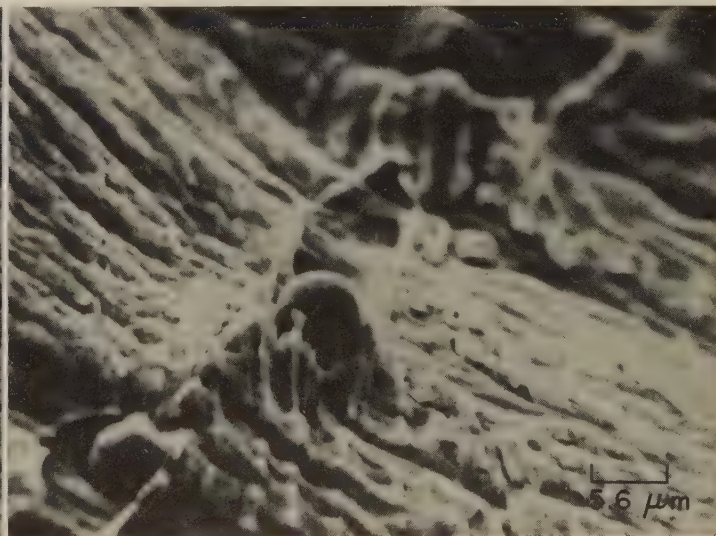
SEM fractograph 1800×
3568 Lower-magnification view of the shear-lip region shown in 3567. Coarse, globular FeO inclusions appear to lie in a trough in every instance; this is attributed to deformation by rigid-body rotation.

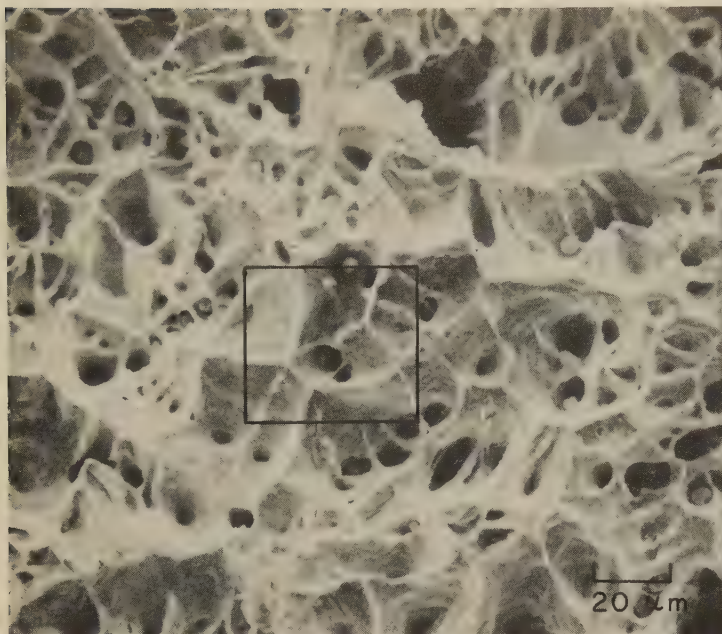
SEM fractograph 500×
3569 Surface of tensile-test fracture in specimen of low-carbon, high-oxygen iron that was broken at room temperature. Many of the equiaxed dimples contain spheroidal particles of FeO. The rectangle marks the area shown at higher magnification in fractographs 3570 (right) and 3571 (below).

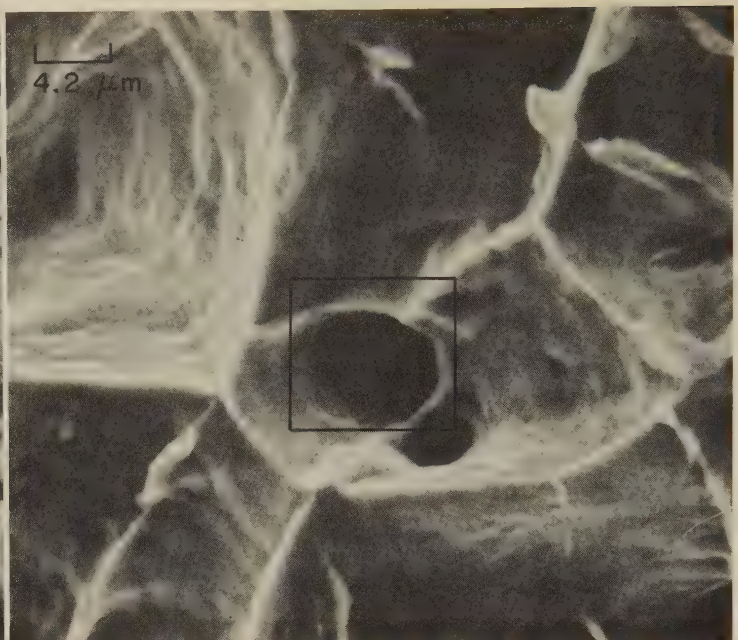
SEM fractograph 2400×
3570 Enlargement of the area within the rectangle in 3569 (left), showing the surface contours of the dimple cavities of the very ductile fracture. Dimly visible in the central dimple is a globular particle of FeO; the particle is shown more clearly in 3571. The rectangle here indicates the area shown in 3572 (below).

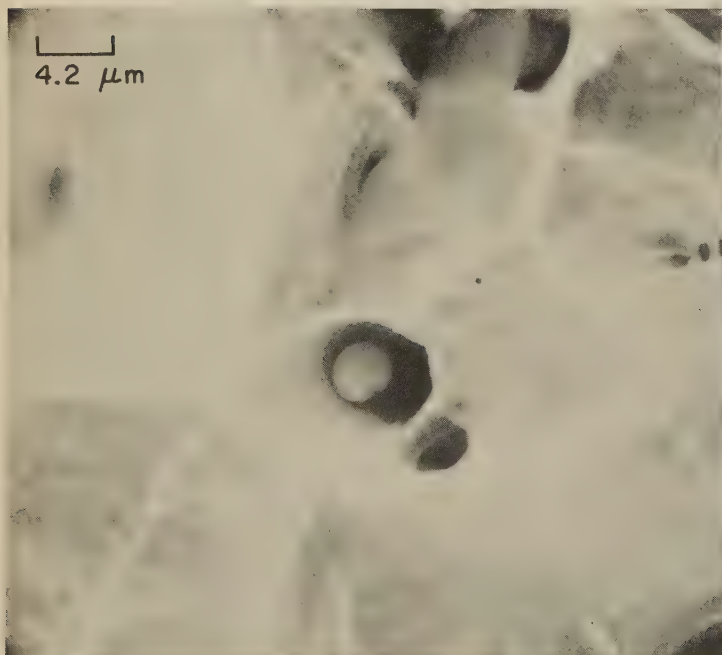
SEM fractograph 2400×
3571 Same fracture-surface area as that shown in fractograph 3570 (at right, above), but processed with a different exposure to bring out the shape and size of the globular particle of FeO in the central dimple. The small dark spot at the lower right on the FeO particle is a shrinkage area.

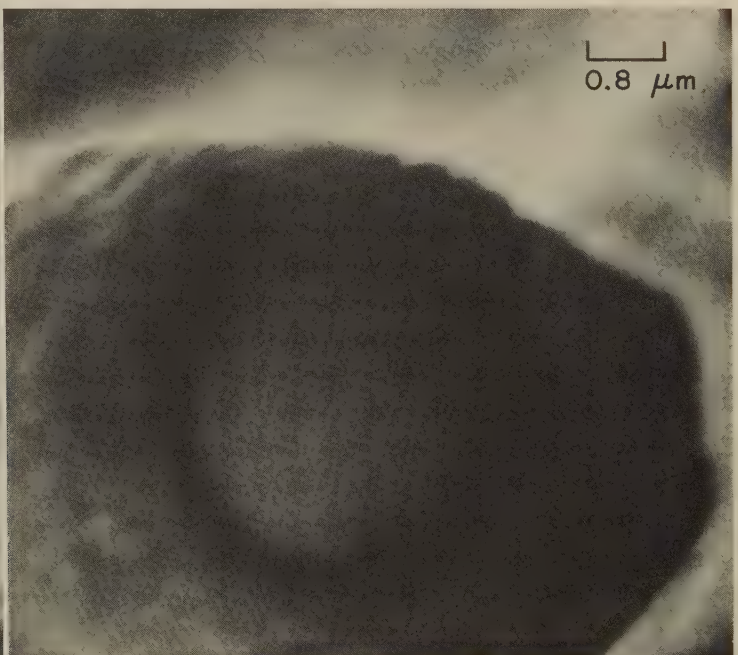
SEM fractograph 12,000×
3572 A further enlargement of the dimple shown in 3569 (center of outlined area) and in 3570. The particle of FeO is remarkably spherical. It seems evident that during the flow leading to fracture the matrix separated and drew away from the FeO particle without fracturing it.

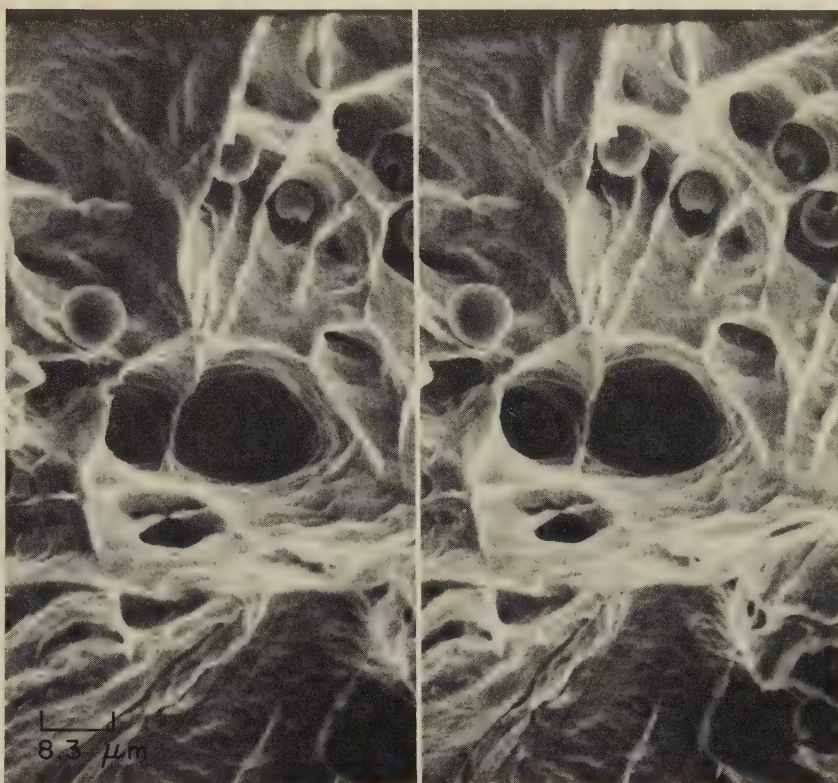
3573 Stereo pair of scanning electron microscope fractographs of the surface of a tensile-test fracture obtained at room temperature. The alloy was a low-carbon iron to which an appreciable amount of Fe_2O_3 had been added to form an aggregate of FeO inclusions. The dimples that are characteristic of ductile rupture are evident here, and many of these dimples contain one or more globular oxide inclusions that are readily apparent. There appear to be two sizes of these oxide inclusions — some being about $6\text{ }\mu\text{m}$ in diameter and others about $3\text{ }\mu\text{m}$ in diameter. Unlike many inclusions displayed in other fractographs, which have relatively smooth, unbroken contours, several of the particles shown here possess sizable surface defects. Some of these defects may be exposed internal shrinkage cavities. The surfaces of the dimples show contours that vaguely resemble fatigue-striation marks. The differences in topographic contours of the dimples displayed in this stereo pair of fractographs can be appreciated only by viewing them stereographically. Whether this is achieved with the aid of the viewer supplied with this volume or a commercially available optical viewer, or with the use of a vertical piece of cardboard to separate the vision of the eyes (as discussed under "Stereoscopic Viewing" in the introduction to the section of this Atlas that follows, "Comparison of SEM and TEM Stereofractographs"), is not of any real importance. However, only by the use of some technique of this sort can the observer train his eyes to view the two prints independently and thereby gain a three-dimensional aspect. It then becomes apparent that the dimples are chimneylike cavities with nearly vertical walls in many instances and with bottoms at great depth that appear black and without detail. The FeO inclusions appear to cling to the cavity walls, many at a point partway to the bottom of the "chimney". Most of the separating walls between adjacent chimneys are extremely thin, which makes it surprising that these walls did not rupture at a point closer to the bottom of the chimney.

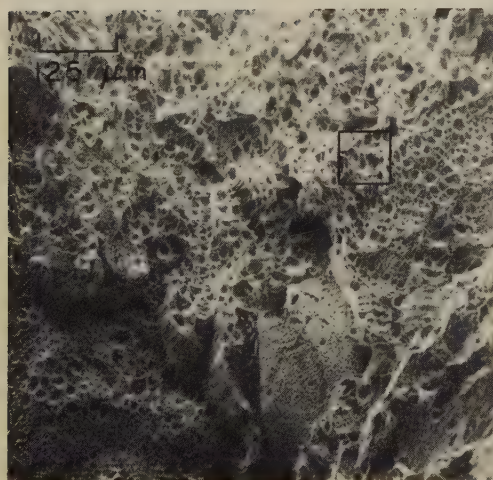
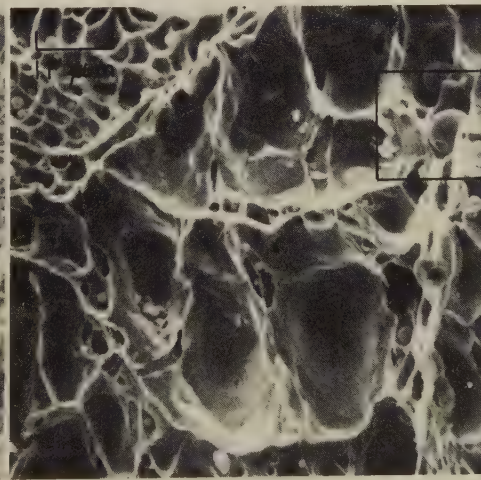
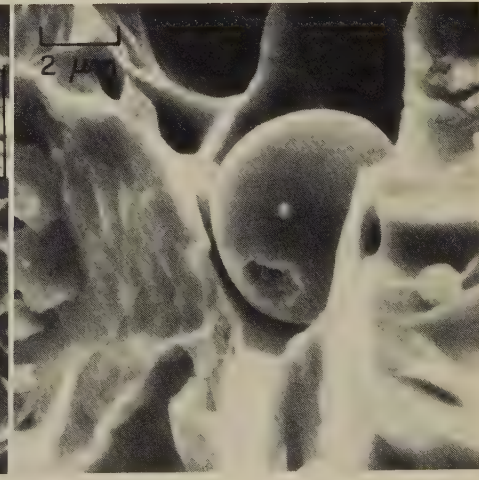
Sequence of SEM fractographs, at increasing magnifications, which show a fracture in an iron alloy containing 0.14% S and 0.04% O. The fracture was obtained by bending at room temperature. Several spheroidal oxide inclusions and sulfide inclusions are visible, most of them having diameters in the range of 1 to $3\text{ }\mu\text{m}$. The rectangle in fractograph 3574 (left) indicates the area that is shown at higher magnification in fractograph 3575 (center), and the rectangle in 3575 indicates the area that is shown at still higher magnification in fractograph 3576 (right). The $6\text{-}\mu\text{m}$ -diam oxysulfide particle in fractograph 3576 shows a shrinkage cavity plus a white spot from an electron beam impingement in fluorescent x-ray analysis. It is quite evident that, during the process of microvoid coalescence, the iron matrix has become detached from the globular inclusions at the metal-to-oxide and metal-to-sulfide interfaces, leaving these inclusions unaffected by the applied stresses and severe deformation taking place around them.

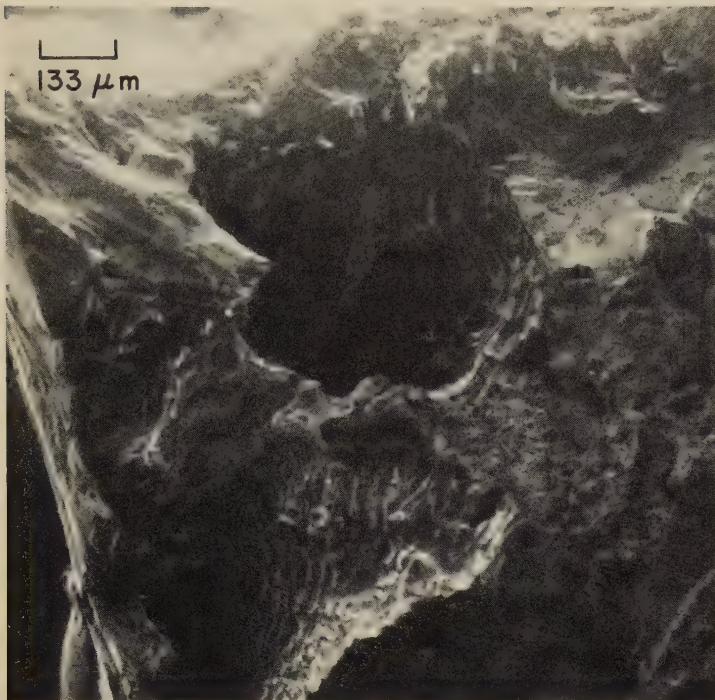
SEM fractograph 75×
3577 Fracture produced at room temperature by bending iron containing 0.02% C, 0.14% S and 0.04% O that had been cast in a 7 by 7 by 20 cm ingot mold. A carbon-FeO reaction caused blowholes such as that shown at top. Note the fine lamellar structure at bottom. See also 3578.

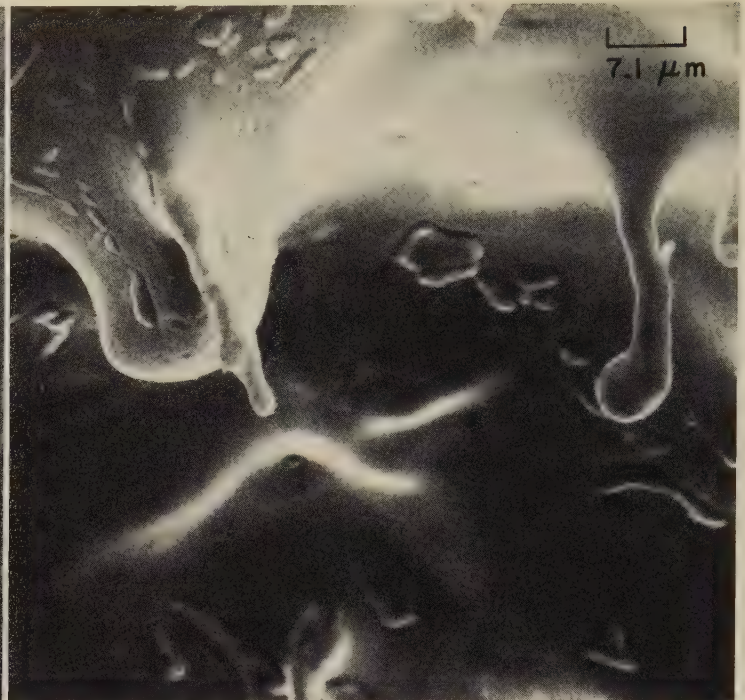
SEM fractograph 1400×
3578 Higher-magnification view of the blowhole shown at the top in fractograph 3577 (at left), showing the interior of the blowhole that resulted from the carbon-FeO reaction. The pendants are droplets of a liquid oxysulfide that spread over the surface of the blowhole during freezing of the ingot.

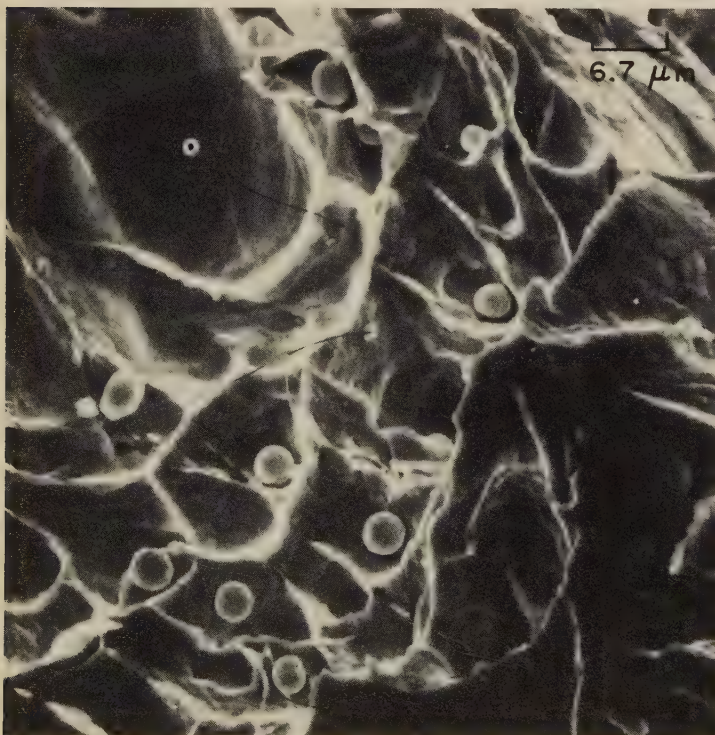
SEM fractograph 1500×
3579 Fracture by room-temperature bending in casting of similar composition to that of casting in 3577 (above) but containing 1.1% Mn. The numerous inclusions contained within the dimples are particles of manganese oxide and manganese sulfide that were trapped between growing dendrite branches.

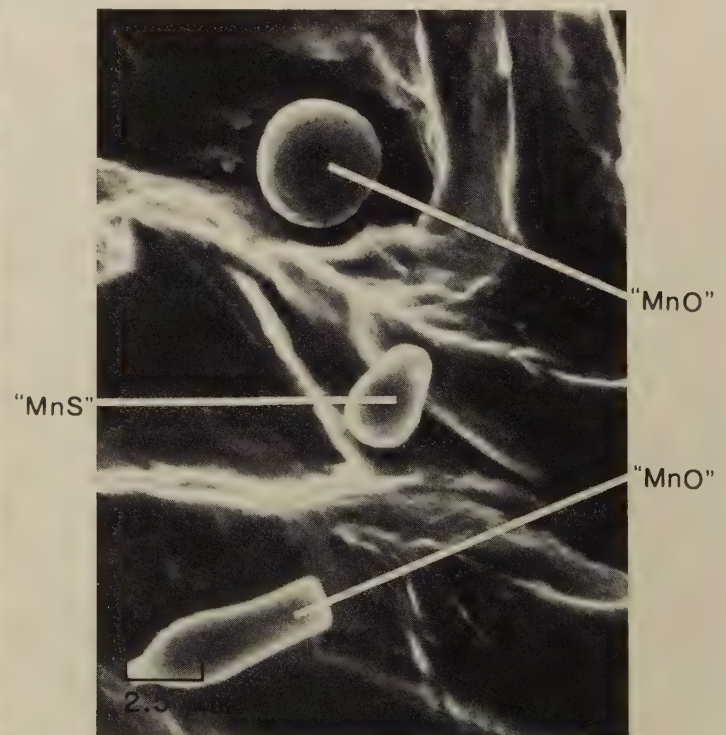
SEM fractograph 4000×
3580 A higher-magnification view of the same fractured specimen shown in fractograph 3579 (left). X-ray fluorescent analysis of the inclusions indicates that some of them are Mn(Fe)O and that others are Mn(Fe)S, but the exact amount of contained iron was not determined.

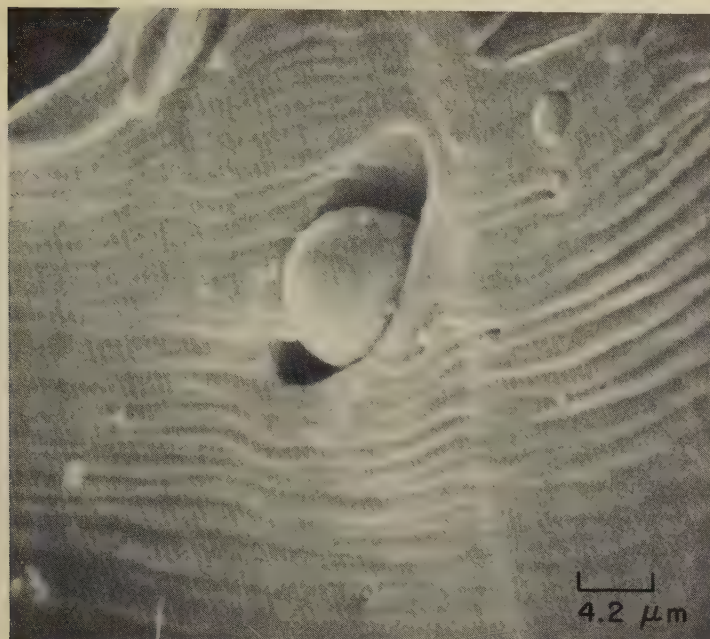
3581 Low-carbon iron containing a high percentage of oxygen, fractured in fatigue at room temperature. A large oxide inclusion has been nearly completely disengaged from its original pocket. Fatigue striations detour around, or extend into, the pocket. Crack propagation was from bottom to top.

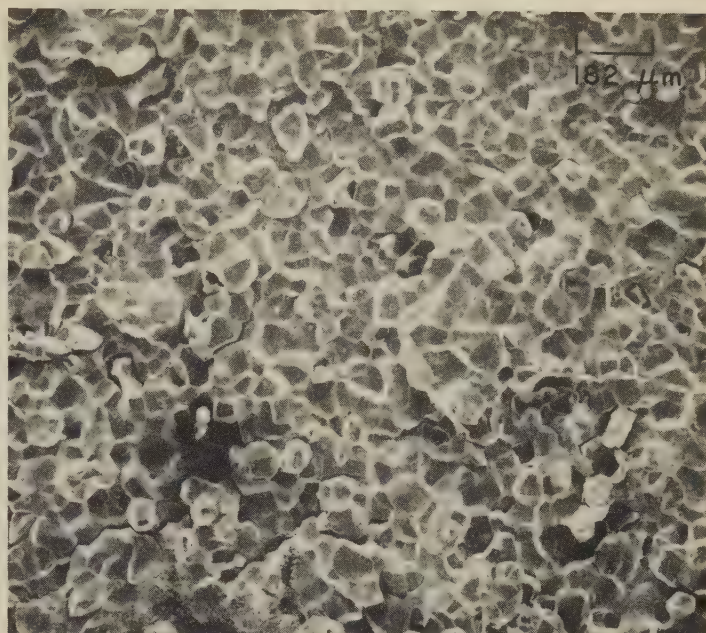
3582 Intergranular fracture that was generated in a specimen of oxygen-embrittled Armco iron by a Charpy impact test at room temperature. The grain facets appear sharp and clean. Note the secondary cracks, which follow grain boundaries. See also 3583 and 3584.

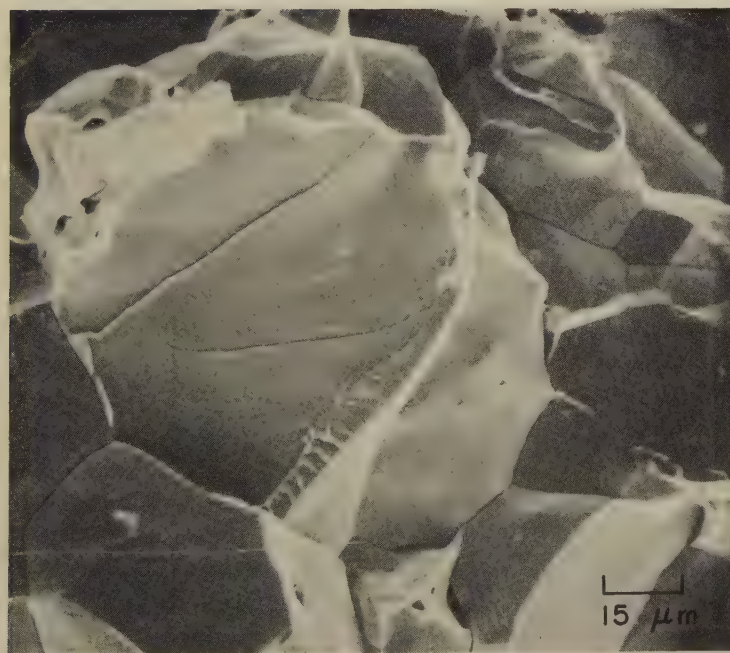
3583 View of another region of the surface of the impact fracture in Armco iron in 3582, showing facets that resulted from a combination of intergranular rupture and transcrystalline cleavage. Note the array of small river patterns at the bottom edge of the large facet at center. See also fractograph 3584.

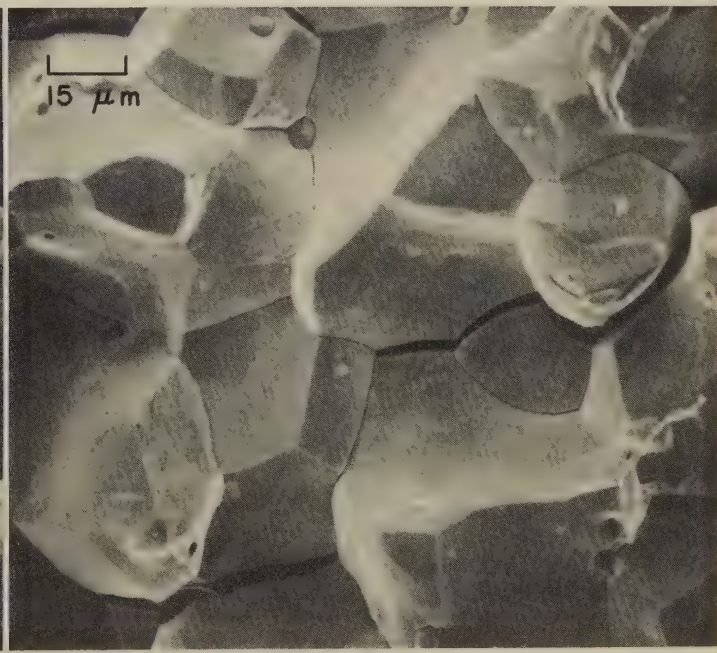
3584 View of a third region of the surface of the impact fracture in Armco iron in 3582 and 3583. Note the almost perfect grain-boundary surfaces and the sharp edges and points at which the separated-grain facets meet. The secondary cracks are equally clean separations.

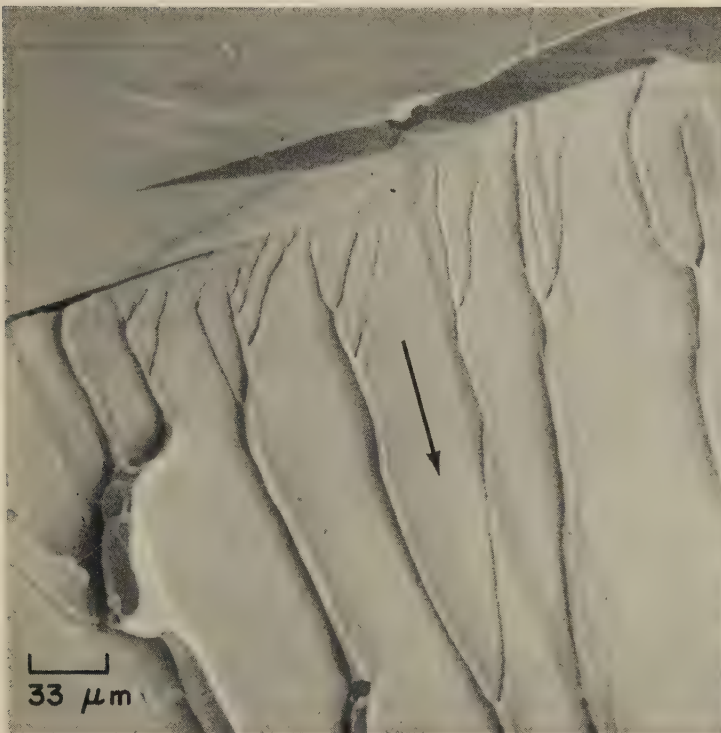
SEM fractograph 300×
3585 Fe, 0.01% C, 0.24% Mn and 0.02% Si, heat treated at 950°C (1742°F) $\frac{1}{2}$ hr, air cooled. The structure is ferrite. Hardness, 62 dph. The fracture was generated by impact at -196°C (-321°F). Cleavage steps beginning at the twin at top form a sharply defined river pattern. Crack propagation was in direction of arrow.

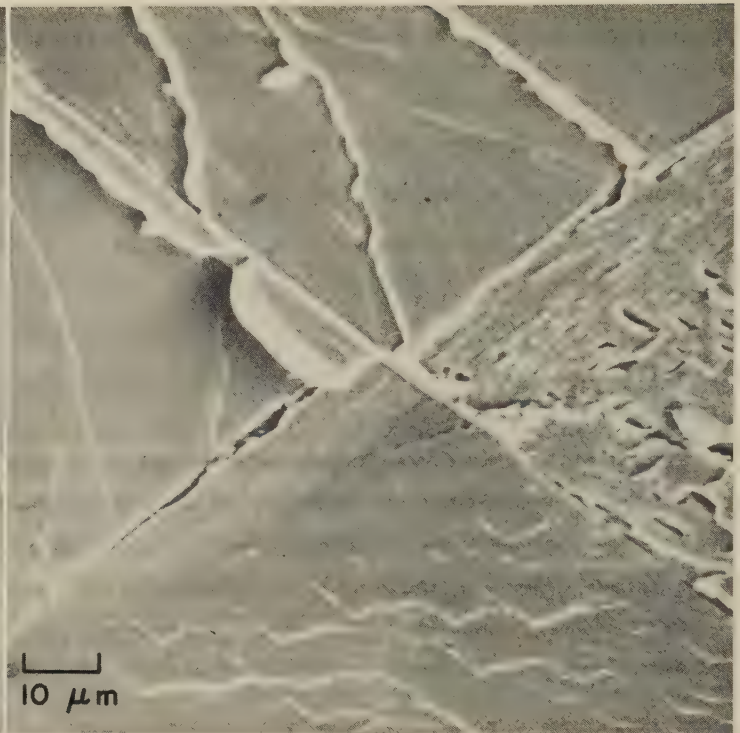
SEM fractograph 1000×
3586 Higher-magnification view of the specimen in 3585, showing the blocklike cleavage pattern that is characteristic of low-temperature impact of low-carbon iron. The well-defined tongue at the center of the fractograph is typical. Secondary cracks are visible as well.

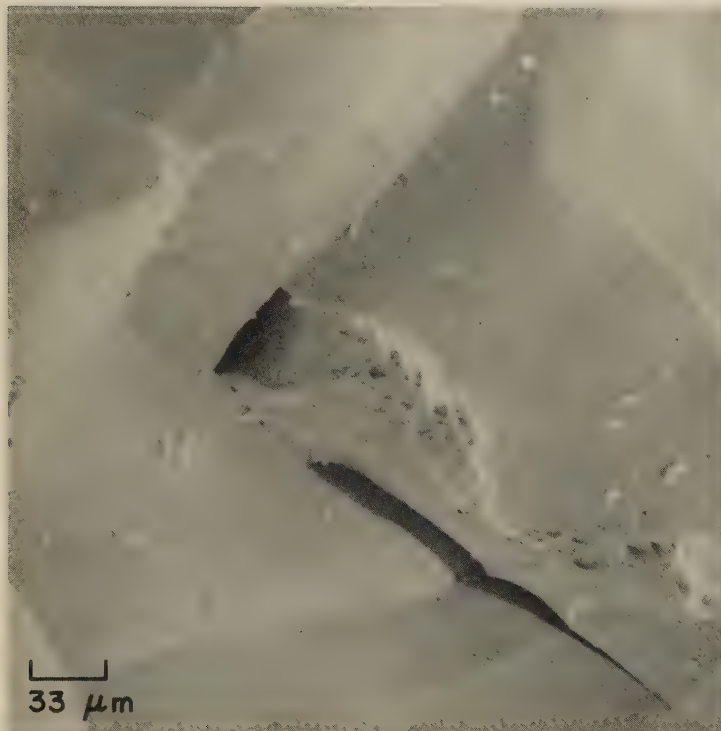
SEM fractograph 300×
3587 Impact fracture generated at 100°C (212°F) in the same material as that shown in 3585 (above). Absorbed energy was 1.6 kgm/cm^2 . Most of the surface is composed of smooth grain-boundary facets, but there is a small area of somewhat elongated dimples near the center.

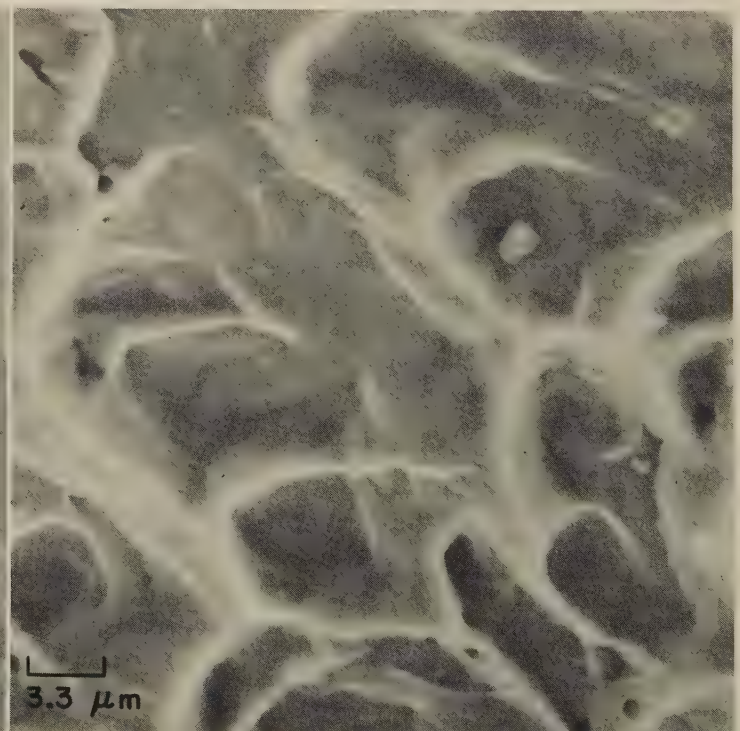
SEM fractograph 3000×
3588 Higher-magnification view of a dimpled area of the fracture shown in fractograph 3587 (at left). The rupture is completely transgranular at this location. Note the slight elongation of the dimples, which reflects the ductile tearing that occurred during impact testing.

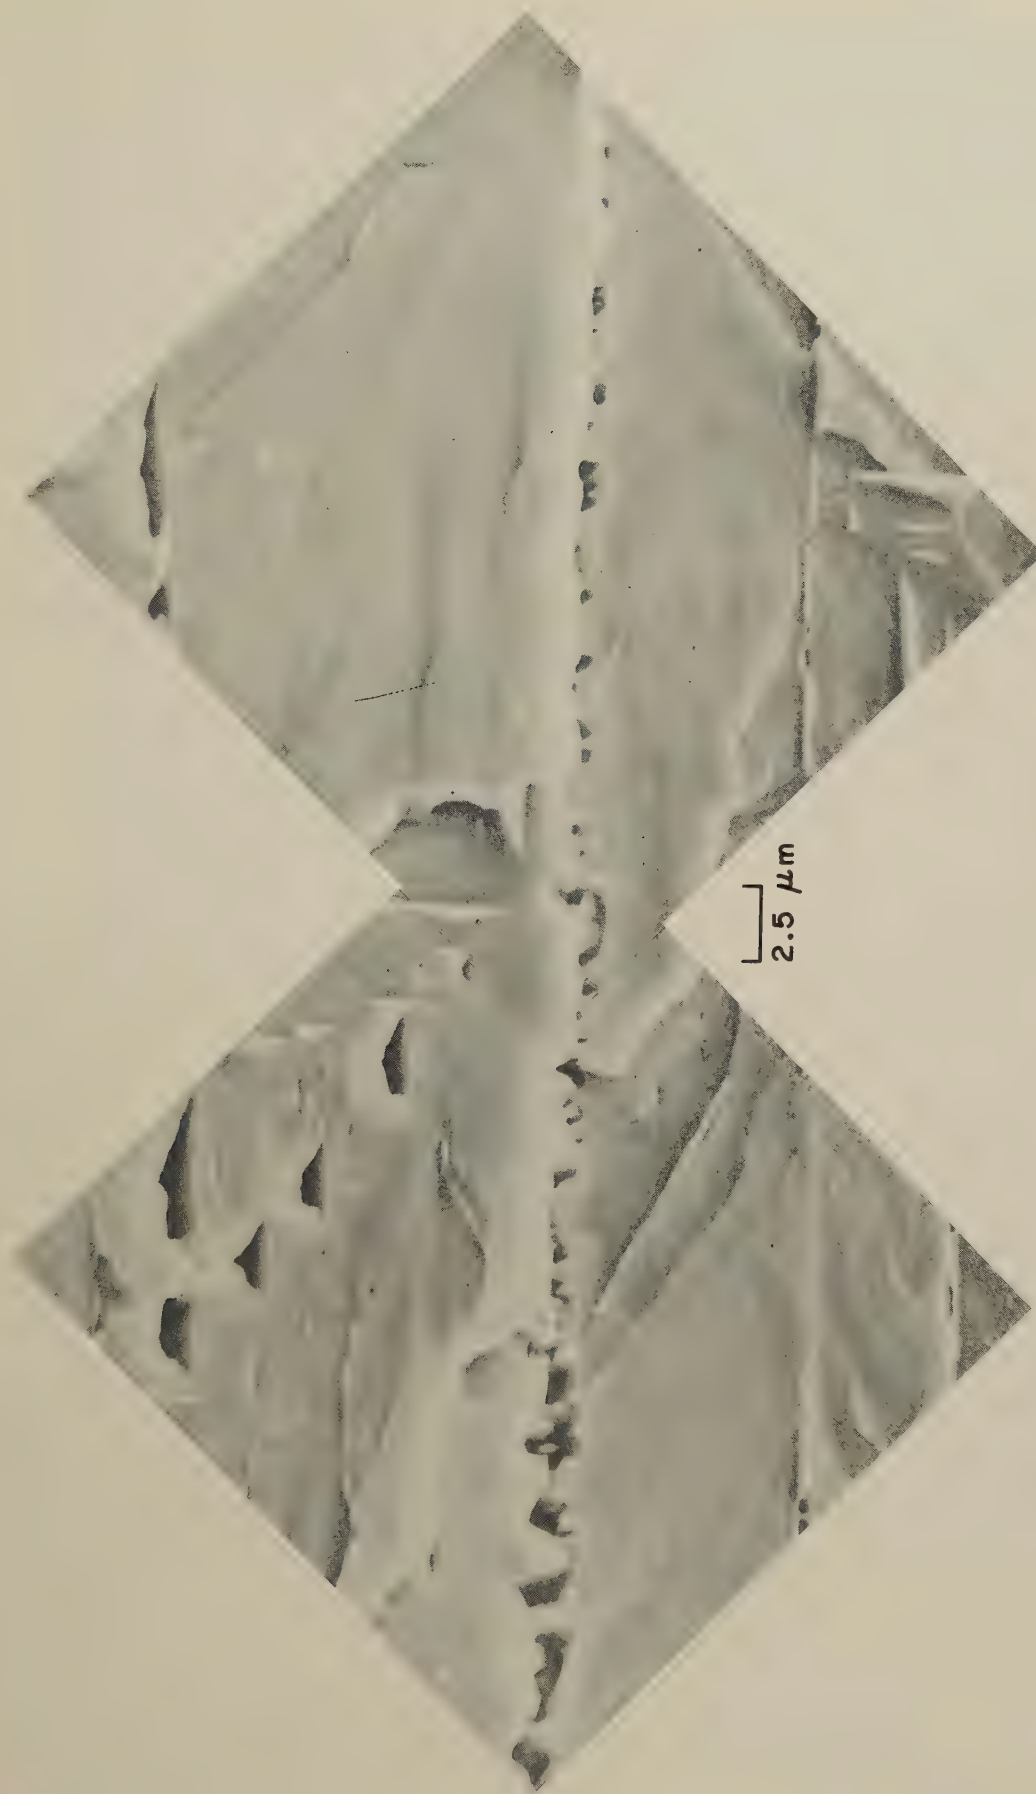
SEM fractographs (overlapping views) 4000×
3589 Two overlapping views of the surface of a brittle fracture in a specimen of high-purity iron containing 0.023% carbon. The specimen was aged at 400°C (752°F) for 1 hour. After being machined to final dimensions and notched parallel to the $\langle 110 \rangle$ direction of the crystal, the specimen was fractured by bending at -196°C (-321°F). Note that the cleavage surface intersects a twin boundary that extends across both prints. The fracture has departed from the general plane of propagation at several points in the twinned metal (upper portion of the prints); the small angle of departure indicates that the plane of the twin is nearly parallel to the general plane of the crack. Many of these departures bear some resemblance to the tongues that are characteristic of cleavage in iron at dry-ice temperature, but they appear to lack the typical projecting overhang that has been observed in so many studies. In addition to these features, a number of cleavage steps in various orientations are visible, some of these being quite irregular in contour and quite unlike the symmetrical blocklike patterns sometimes encountered in fracture surfaces of iron specimens fractured at this very low temperature.

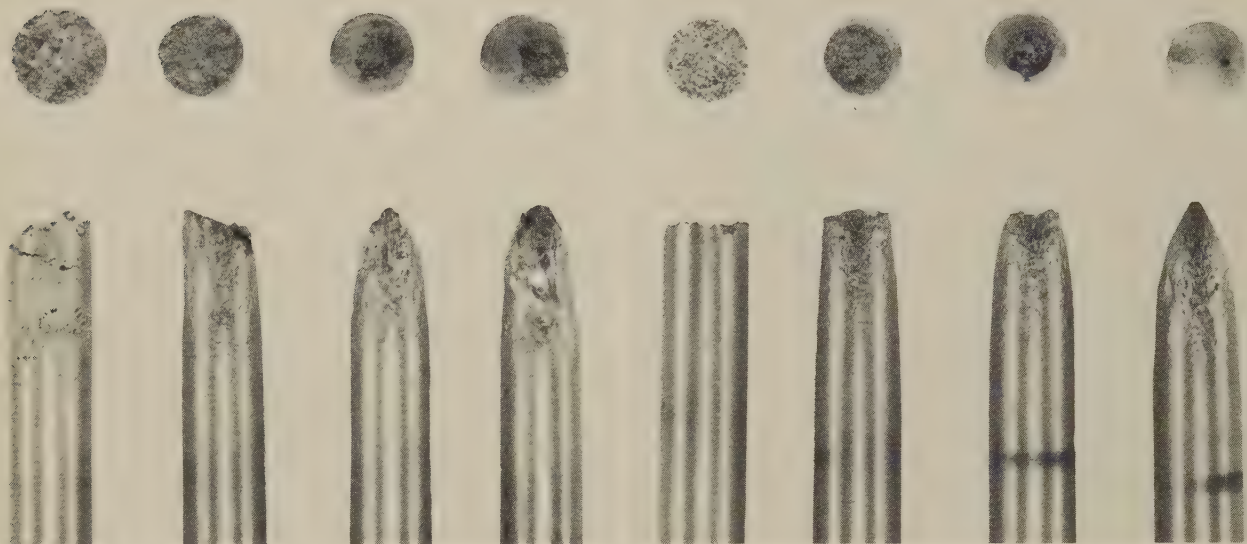
3590, 3591 Fractures obtained in tension in low-carbon steel specimens that were tested at elevated temperature. The specimens were taken from a series of 500-lb laboratory heats melted to yield a range of carbon contents (0.04 to 0.08%) and a range of Mn:S ratios (11:1 to 68:1). The ingots were rolled to 3/4-in. and 5/8-in. plate at 1177 C (2150 F). The specimens shown in 3590 (left) were machined, placed within a silica sleeve in a Gleeble test unit and remelted in the central region of the gage length. They were then solidified *in situ*, cooled to 1427 C (2600 F) at 14 C (25 F) per second, cooled to either 1093 C (2000 F) or 927 C (1700 F) at 5.5 C (10 F) per second, and then pulled to rupture. From left to right, the Mn:S ratios were 11, 22, 38 and 63 to 1, and the reductions in area were 6, 37, 63 and 83%. The specimens shown in 3591 (right) were "sensitized" in the Gleeble test unit by heating to 1427 C (2600 F), holding for 300 sec, and then cooling at 5.5 C (10 F) per second to 1093 C (2000 F), and were broken in tension at the latter temperature. From left to right, the Mn:S ratios were 14, 22, 36 and 62 to 1, and the reductions in area were 4, 47, 74 and 99%.

3592 Fracture in low-carbon steel containing 0.065% C, 0.52% Mn, 0.01% P, 0.022% S and 0.076% Si (Mn:S ratio, 23.6:1). The specimen was "sensitized", and broken in tension, as described above for 3591. Under these conditions, a low Mn:S ratio would result in a completely intergranular fracture. However, because of the intermediate ratio here (23.6:1), the grain-boundary facets show dimples in many areas, indicating ductility. Reduction in area was 33%, which agrees with the appearance of the fracture surface.

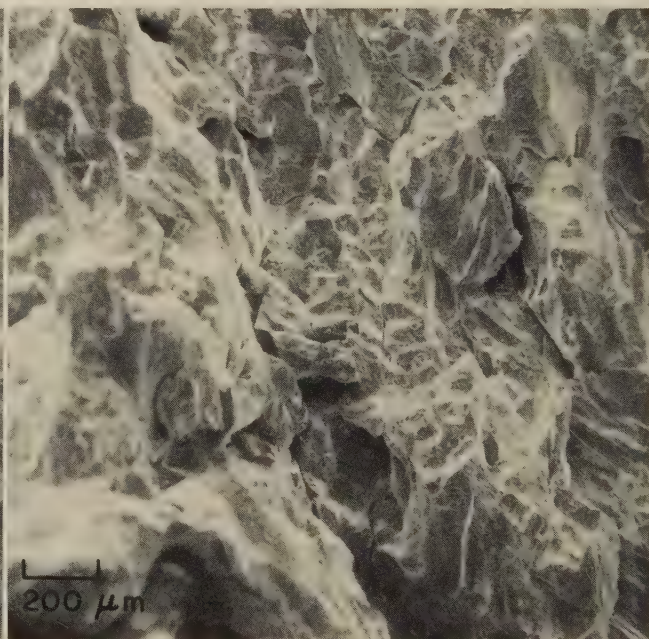
3593 Surface of fracture obtained in test bar of low-carbon steel containing 0.041% C, 0.62% Mn, 0.008% P, 0.028% S, 0.032% Si (Mn:S ratio, 22.1:1). The test bar was remelted in its central zone in a Gleeble test unit, solidifying *in situ* in its quartz sleeve. Following controlled cooling from the freezing point, the test bar was pulled in tension at 927 C (1700 F). Although the path of this fracture was largely intergranular, there is also transgranular cleavage, and some facets show very fine dimples.

SEM fractograph 50×
3594 Fracture very similar to that shown in fractograph 3593. The Mn:S ratio of the steel was 11:1. Tensile rupture (after remelt) occurred at 1093 C (2000 F). The crack followed an intergranular path, but microscopic dimples were found when the fracture surface was examined at higher magnification.

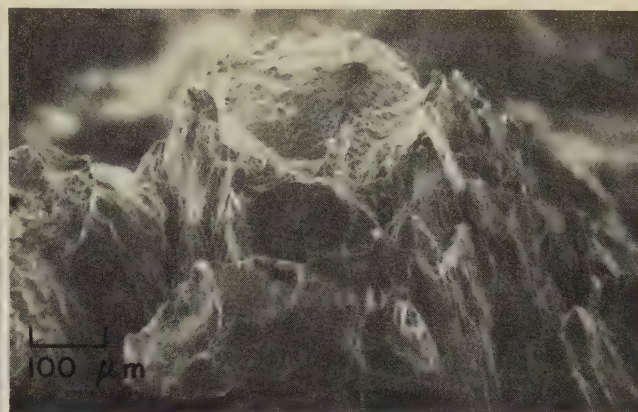
SEM fractograph 100×
3595 Tensile fracture (oblique view) obtained at 927 C (1700 F), after remelt *in situ*, in low-carbon steel (0.054% C, 0.41% Mn, 0.029% P, 0.017% S and 0.041% Si; Mn:S, 24:1). An x-ray spectrum taken at a grain boundary showed a high percentage of sulfur, but no phosphorus (possibly obscured by the sulfur).

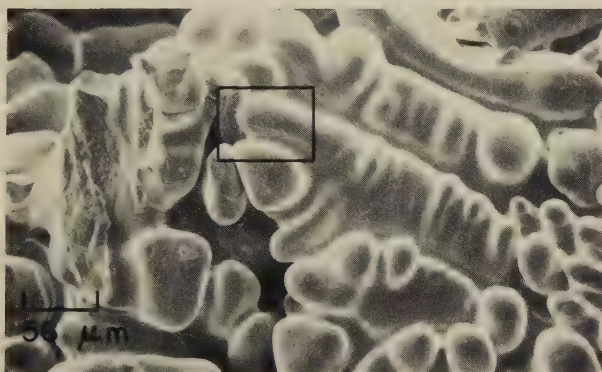
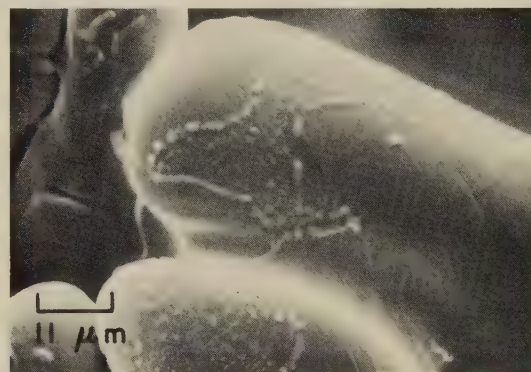
SEM fractograph 180×
3596, 3597 Two SEM views, at different magnifications, of the surface of a brittle fracture in a specimen of 1015 steel whose central zone was remelted in a Gleeble test unit, resolidified, cooled *in situ* to 1427 C (2600 F) and held for 20 sec at that temperature, and then fractured in tension. This specimen contained 0.024% P, but a specimen (from a companion melt) that contained 0.005% P ruptured in the same brittle fashion when remelted and tested in exactly the same manner. Fractograph 3596 (left) indicates that the fracture followed an interdendritic path through regions that had not yet solidified at 1427 C (2600 F). The rounded dendrite surfaces thus exposed are obvious, and the only evidence of a torn surface is in a small area at extreme left. Fractograph 3597 (right), which is a higher-magnification view of the area within the rectangle in 3596, shows patterns of what were confirmed by x-ray fluorescent analysis to have been, at the moment of fracture, liquid droplets of manganese oxysulfide on the dendrite surfaces. These patterns were the only evidence of segregation that was discovered within the fracture, the presence of phosphorus not being detected.

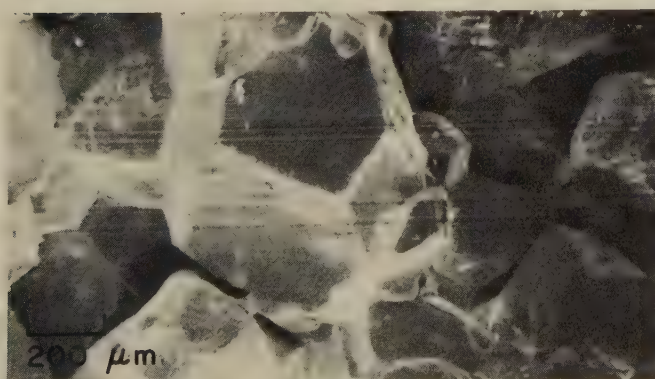
SEM fractograph 50×
3598 Intergranular fracture in a specimen of 1015 steel that was "sensitized" in a Gleeble at 1427 C (2600 F), cooled to 1093 C (2000 F) and broken in tension. The Mn:S ratio was 19:1 (0.45% Mn, 0.024% S). Note pronounced secondary cracking. See 3599.

SEM fractograph 5000×
3599 Higher-magnification view of the fracture in 3598 (at left), showing an unusual rippled surface quite uncharacteristic of cleavage or microvoid coalescence. The larger "bumps" contain manganese and sulfur; the smaller ones were not identified.

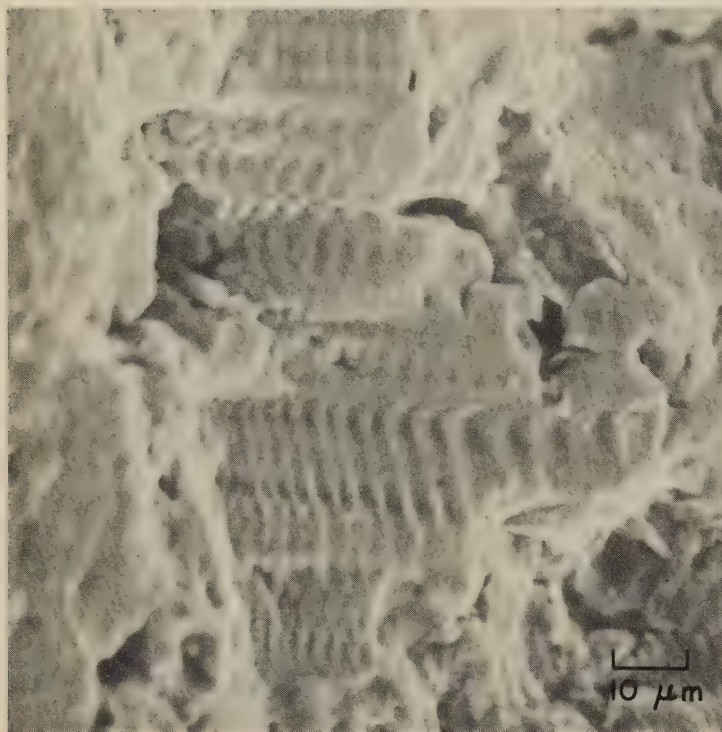
SEM fractograph 1000×
3600 Fracture produced in low-cycle rotary-bending fatigue at room temperature in a specimen of 1020 steel containing 0.20% C, 0.52% Mn and 0.22% Si and normalized at 900 C (1652 F) to a hardness of 146 dph. Applied stress was 480 MPa (69.6 ksi); fracture occurred at 3100 cycles. Surface is quite irregular; area at left is out of focus in the foreground, and upper right recedes into the background. Note abrupt angles in striations. See 3601.

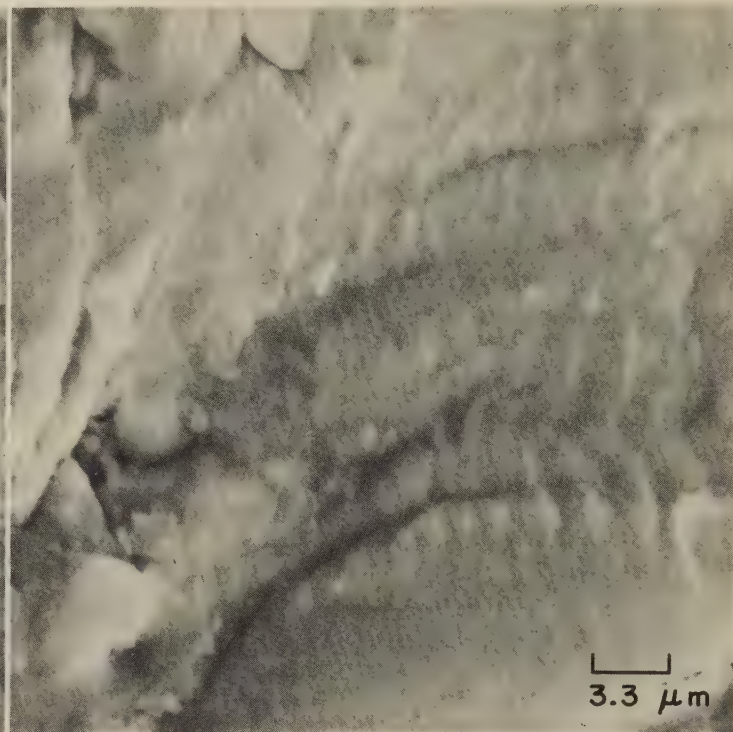
SEM fractograph 3000×
3601 Fracture produced in high-cycle rotary-bending fatigue at room temperature in a specimen of the same material and hardness level as that in fractograph 3600. Applied stress was 252 MPa (36.6 ksi); fracture occurred at 1,505,200 cycles. Fatigue striations are much less sharply defined than in 3600, and the striation spacing is somewhat less, as would be expected at this lower stress level. Secondary cracking is apparent. See 3602 to 3604.
